Effects of Late Holocene Debris Flows on Lava Falls Rapid, Grand Canyon National Park, Arizona

U.S. GEOLOGICAL SURVEY
Open-File Report 96—460

By ROBERT H. WEBB, THEODORE S. MELIS, THOMAS W. WISE, and JOHN G. ELLIOTT

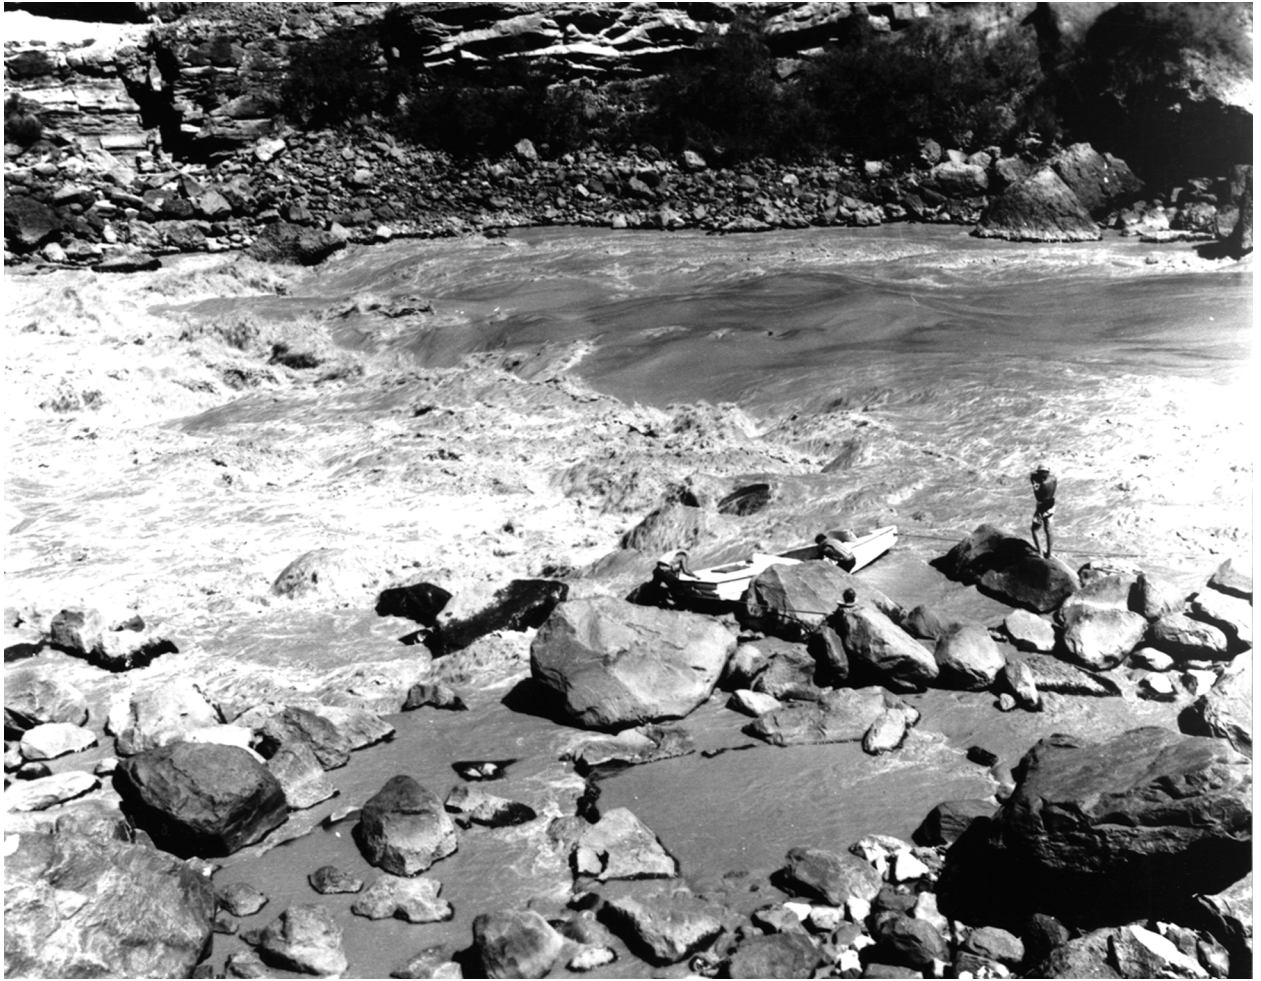
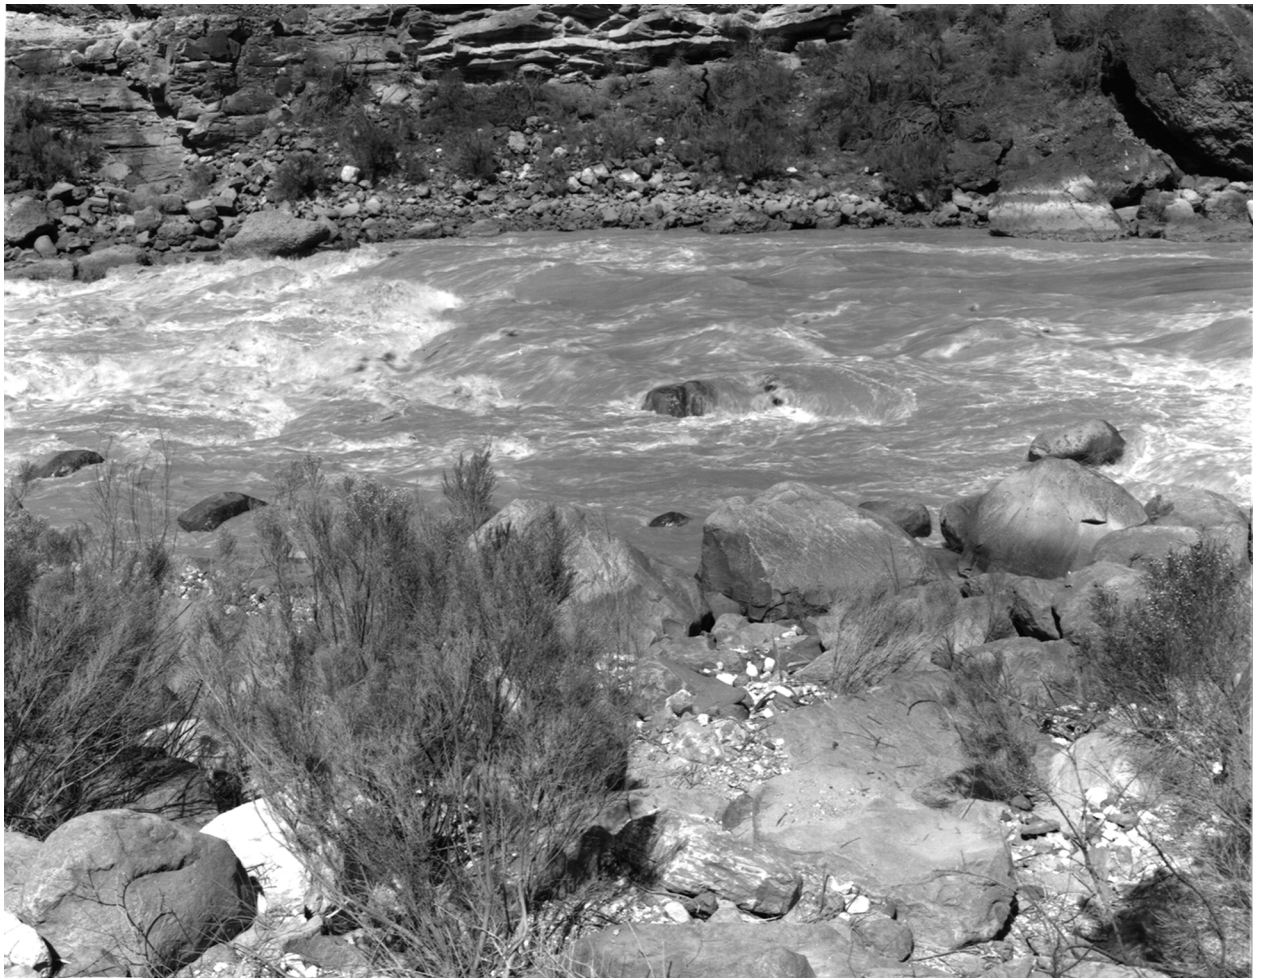
Figure 18. Views of Lava Falls Rapid from the left side (Stake 2660a). A. (July 26, 1942; N. Wilson, courtesy of the University of Utah Marriott Library). In this upstream view, the crew of the Nevills expedition is lining boats along the left side of the rapid. The 1939 debris flow completely changed the flow pattern in the rapid. The Pyramid Rocks were removed from the center of the rapid, and large holes punctuated the left side. The photographer stood on a debris fan that was 3-4 m higher than the fan in 1993; the deposits of the 1939 debris flow were subsequently reworked by Colorado River floods or Prospect Canyon debris flows.

B. (March 10, 1993; S. Tharnstrom). At a discharge of 310-340 m³/s, the apparent stage is about 0.5 m lower than in 1942. Debris flows after 1942 deposited rocks in the center of the rapid that form the Ledge Hole, which does not appear in the 1942 view. Riparian vegetation has invaded the debris fan.

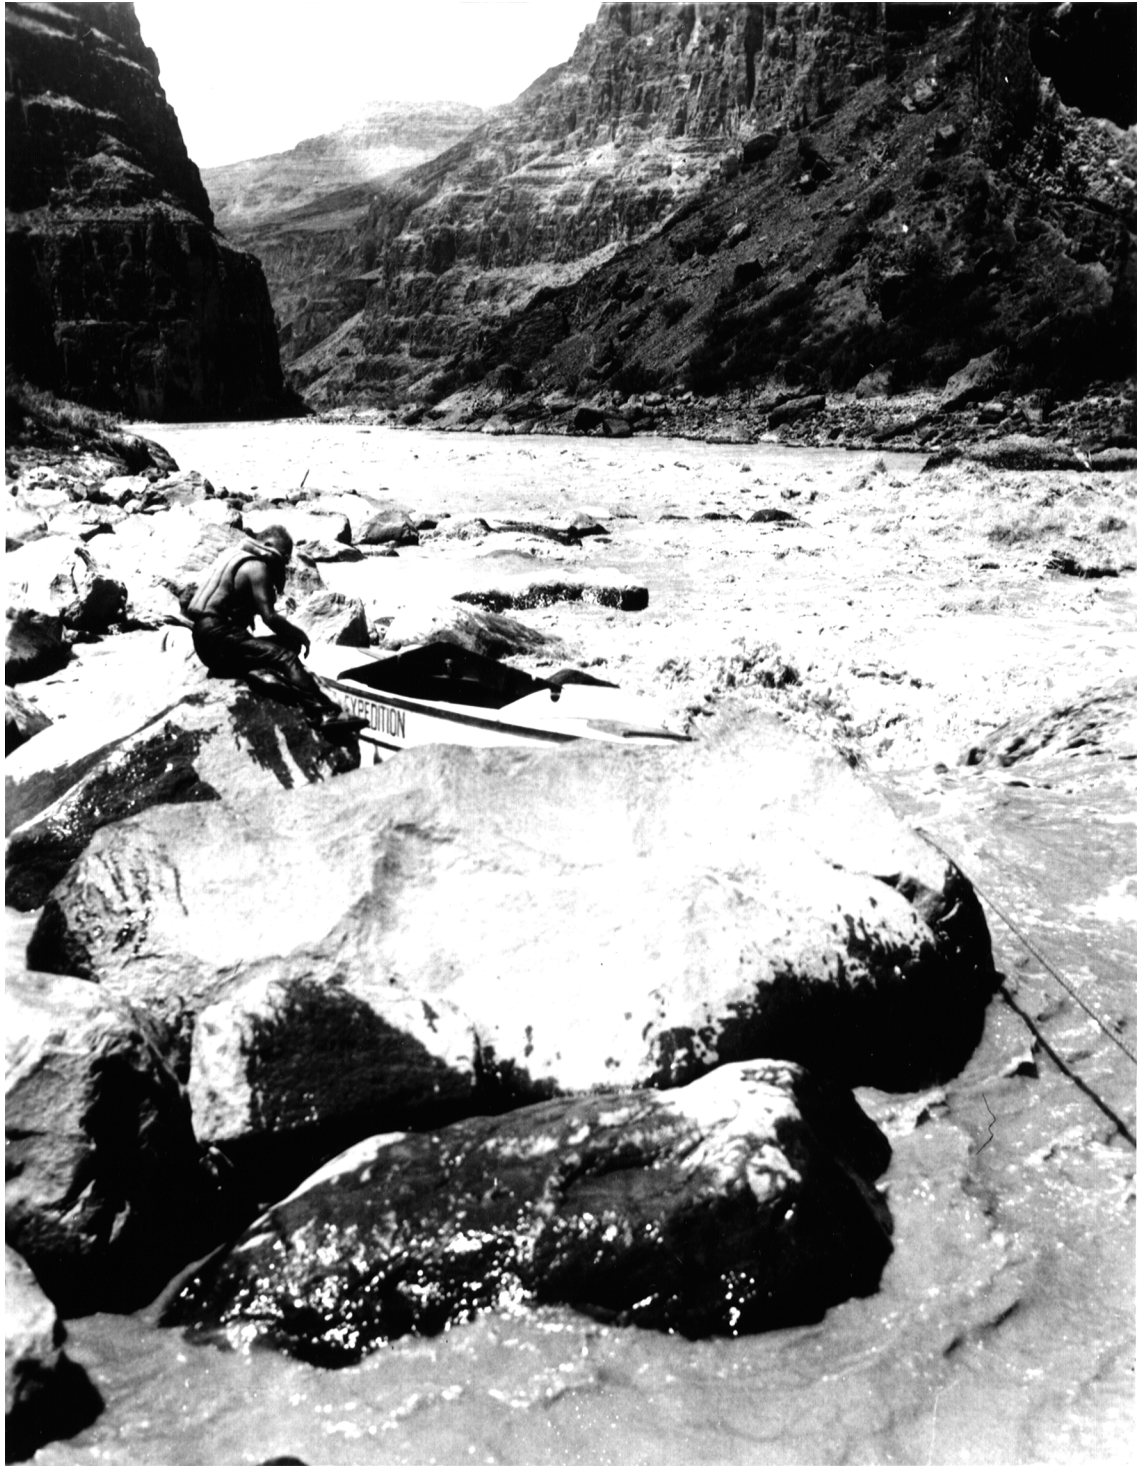
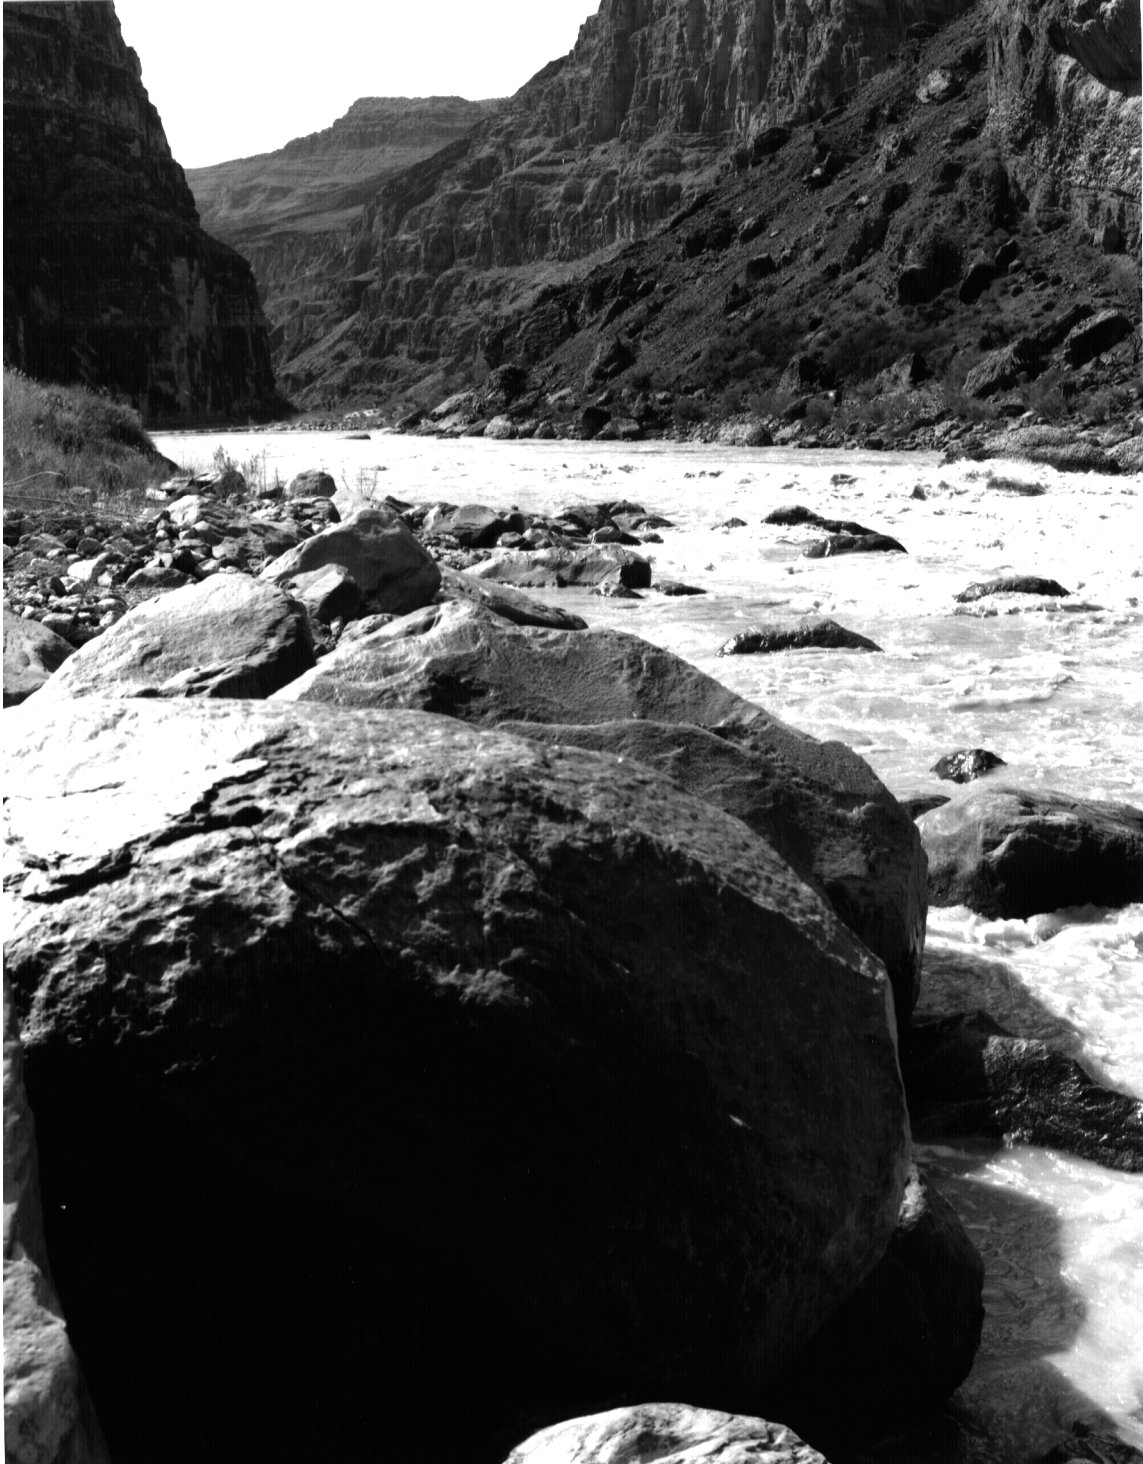
Figure 19. Downstream view of Lava Falls Rapid from the left side (Stake 2741). A. (July 27, 1941; W. Heald, courtesy of the University of Utah Marriott Library). A crew member of the 1941 Nevills expedition rests on a rock during a portage down the left shore. At a discharge of about $570 \text{ m}^3/\text{s}$, water is piling up against the Black Rock, shown in the upper right of the view. The pattern of the tail waves, which has changed in comparison to pre-1939 views, is the result of increased constriction of the Colorado River and displacement of the Deflector Rock during the 1939 debris flow. All foreground rocks in this photograph were deposited in 1939.

B. (March 10, 1993; S. Tharnstrom). Flow in the Colorado River is about $230\text{-}280\text{ m}^3/\text{s}$. Although many boulders have been transported in and out of the field of view by debris flows after 1941, several boulders in the midground remain. The boulder that the crew member is resting on in 1941, as well as the boulders immediately upstream, are in the same place. The foreground boulder, which has a b-axis diameter of 1.85 m, was probably deposited during the 1955 debris flow. The pattern of waves at the bottom of Lava Falls Rapid is similar in 1941 and 1993.

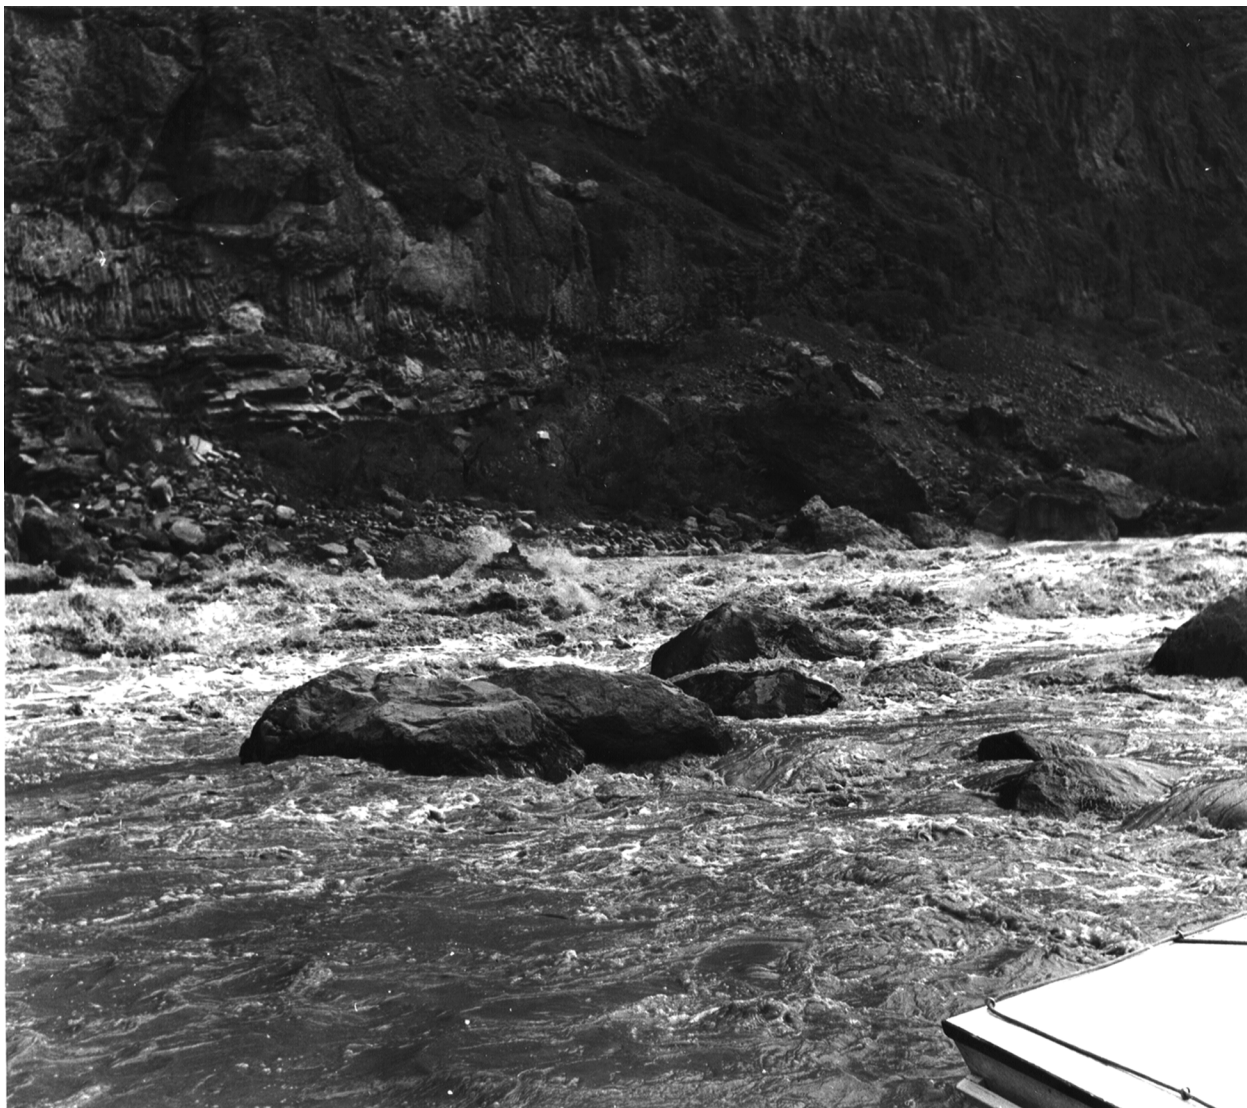
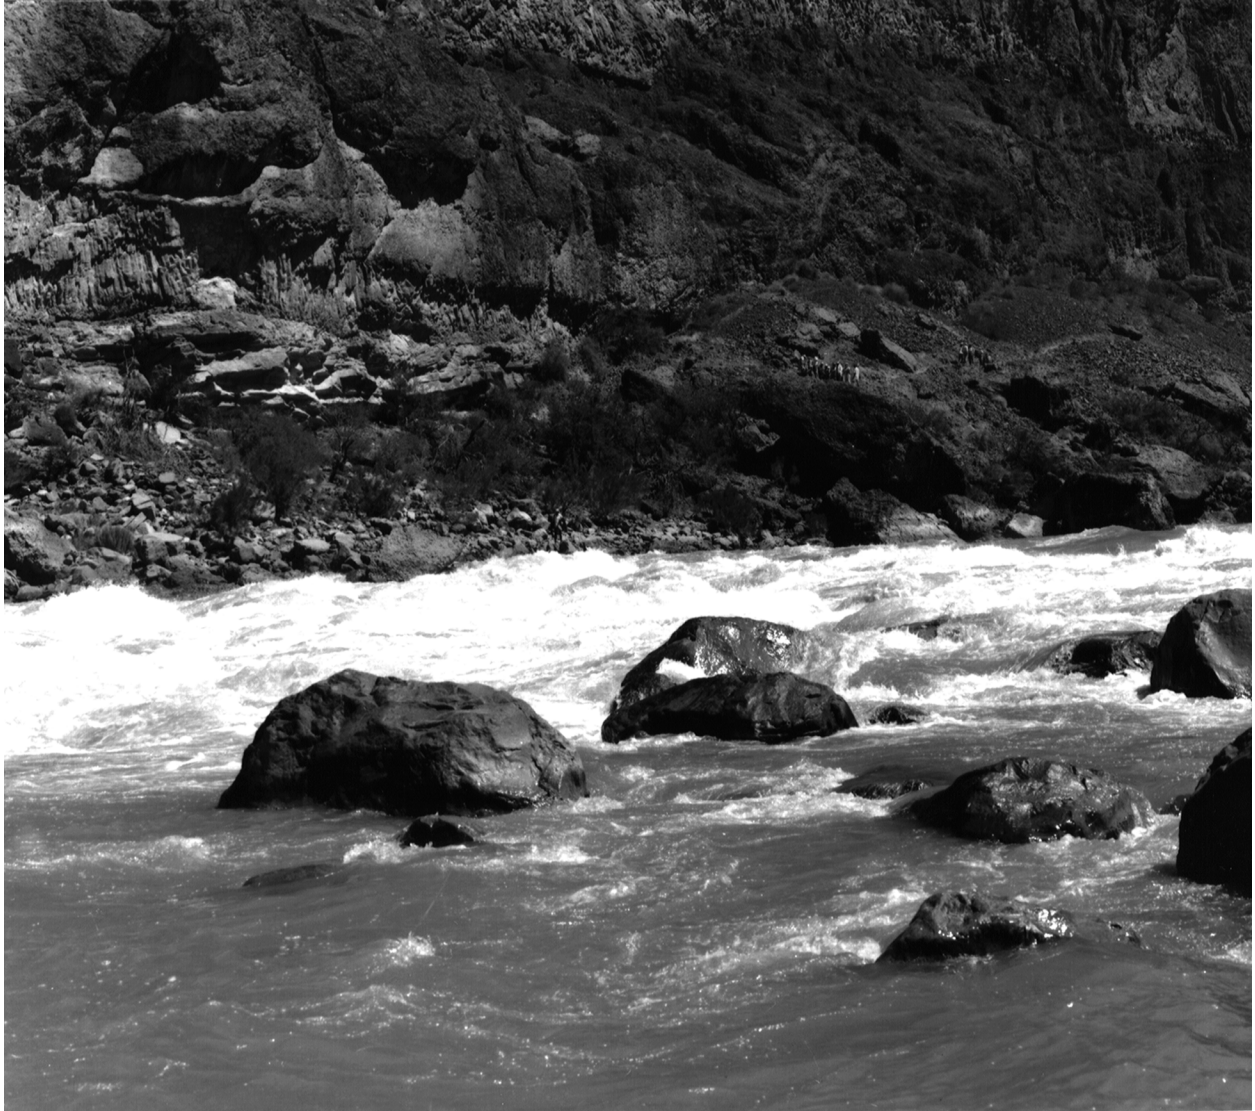
Figure 20. Upstream view of Lava Falls from the left side (Stake 2046).A. (July 7, 1950; P. T. Reilly). A motor boat passes through the V Wave, which appear in the left center of this upstream view. The large boulder at bottom center is approximately 1.5 m in diameter. The discharge is $470 \text{ m}^3/\text{s}$.

B. (August 16, 1991; R.H. Webb). The discharge is slightly lower than in the 1950 photograph. Several boulders in the foreground were not dislodged by debris flow and Colorado River floods after 1950. However, one foreground boulder has been transported out of the field of view. A boulder of approximately the same dimensions was also transported into the field of view (lower right). Both boulders probably were deposited by the 1955 debris flow.

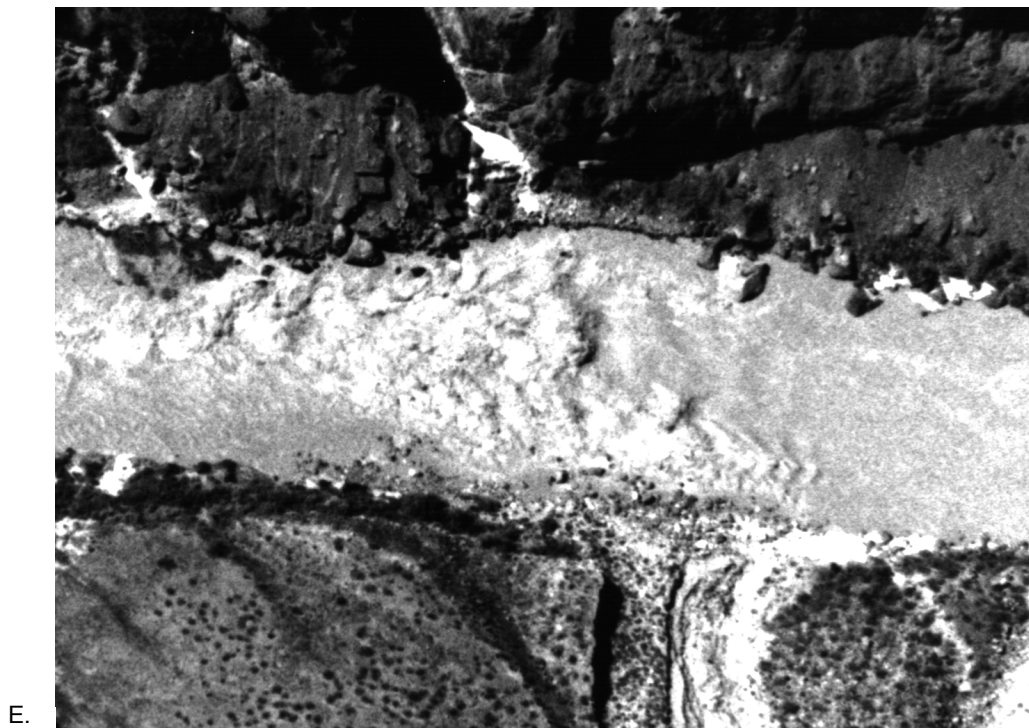
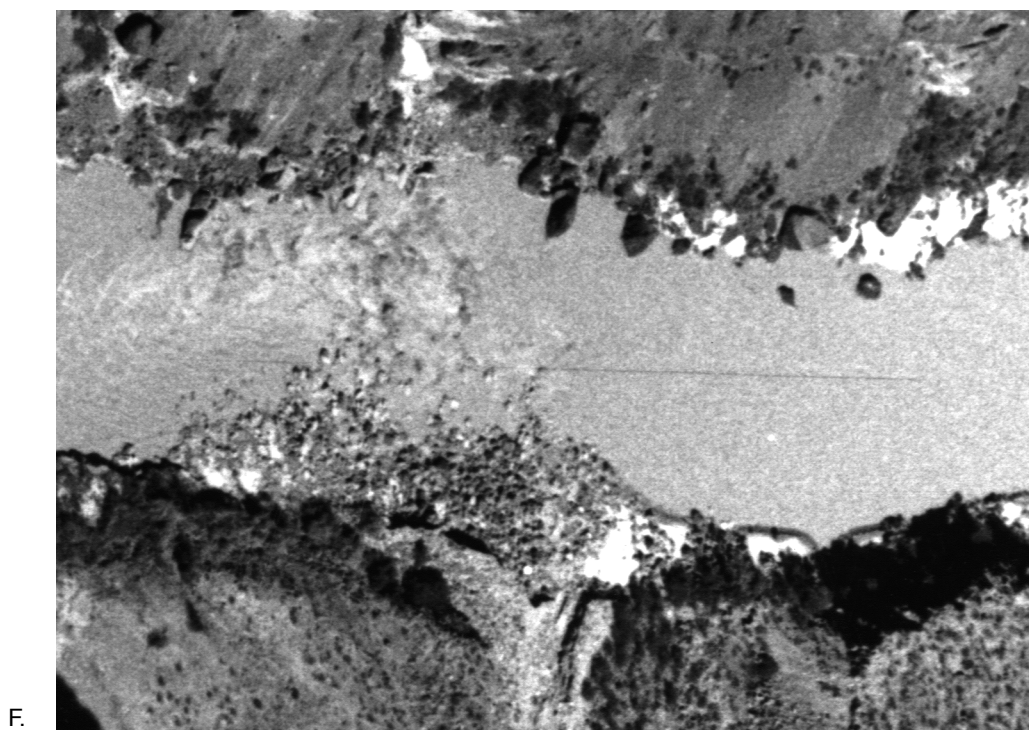
E. (April 20, 1958). The Colorado River peaked at $3,540 \text{ m}^3/\text{s}$ in 1957, and the flood removed most of the 1955 and 1956 debris-fan deposits. Small pockets of 1955 levee deposits were still present in April 1958. The Ledge Hole, which formed after the 1957 flood reworked the 1955 deposit, appears in the center of the rapid, which had a discharge of $1,870 \text{ m}^3/\text{s}$. F. (October 4, 1958). The Colorado River peaked at $3,030 \text{ m}^3/\text{s}$ in 1958, but flow was only $190 \text{ m}^3/\text{s}$ when Reilly took his photograph. Only the largest boulders deposited in 1939 and 1955 remained on the debris fan. The Ledge Hole is distinct at the top center of the rapid, and the Big Wave is present in front of the Black Rock.

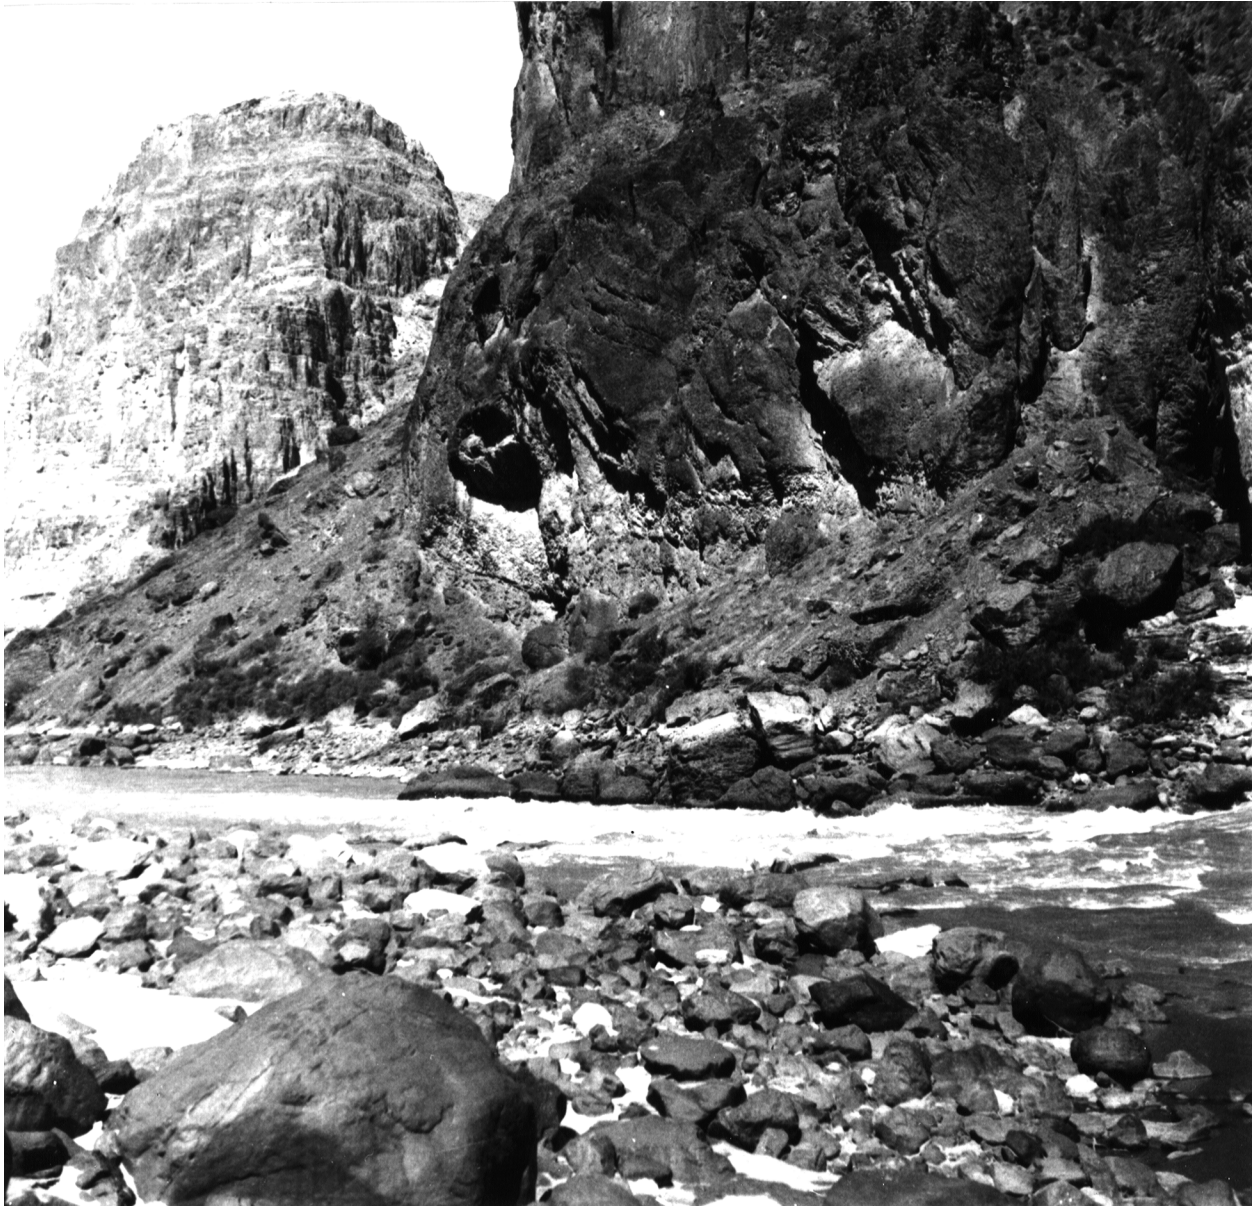
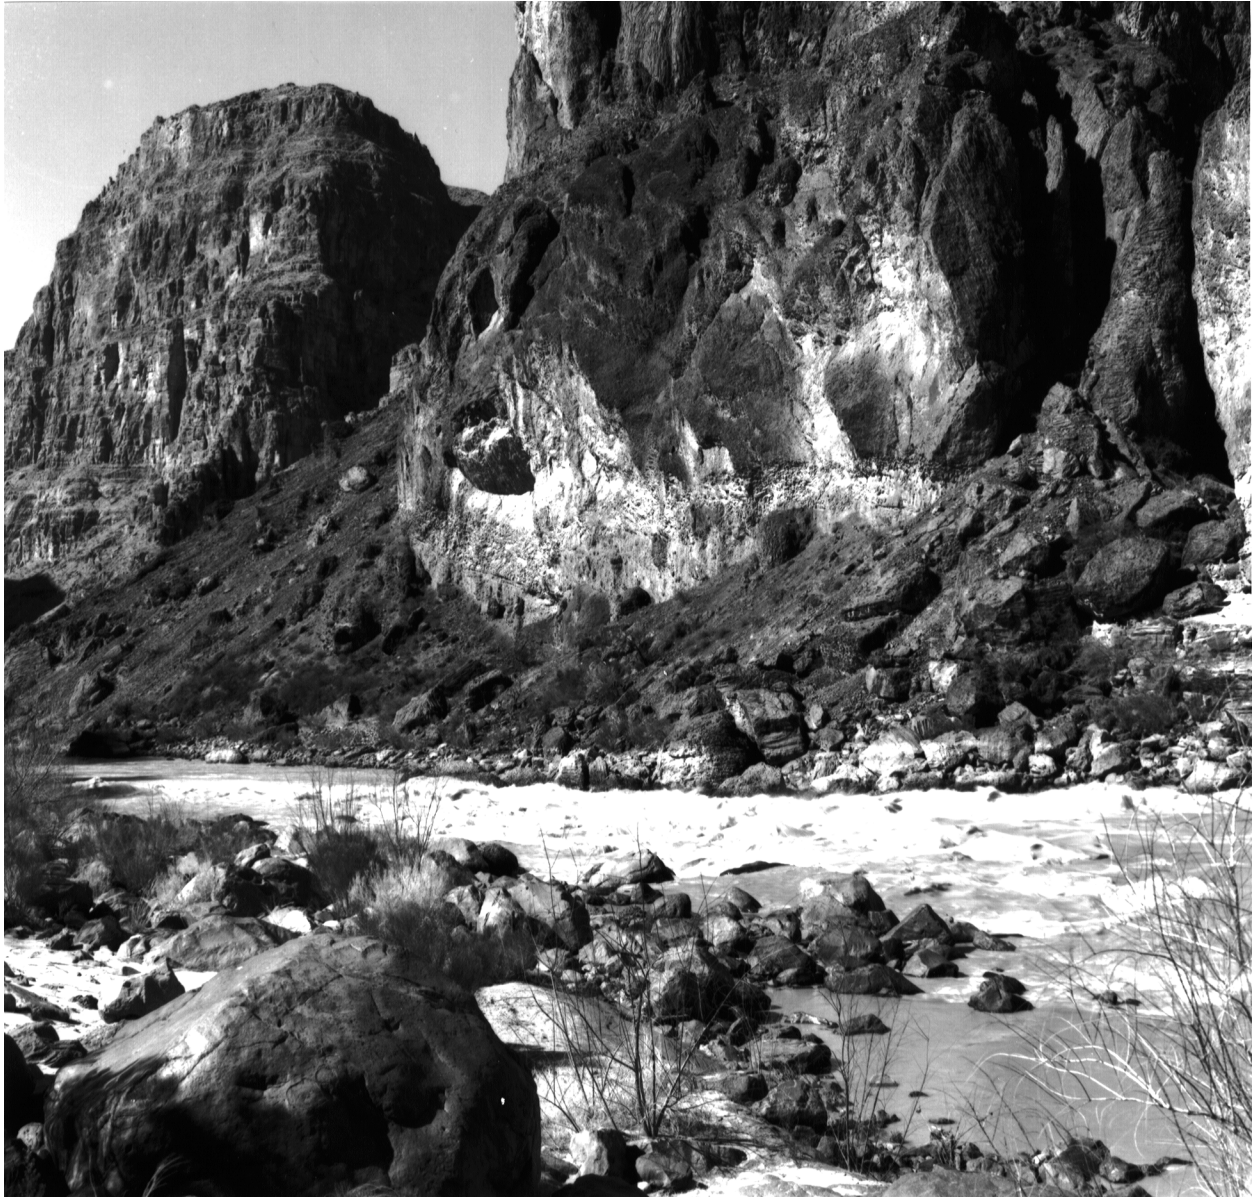
Figure 22. Downstream view of Prospect Canyon debris fan and lower Lava Falls Rapid (Stake 2002). A. (July 20, 1958; G. Staveley, courtesy of the Huntington Library). The discharge is $220 \text{ m}^3/\text{s}$, and the boulders on the debris fan are the net result of the 1939, 1954, and 1955 debris flows and reworking by the Colorado River. The 1957 flood in the Colorado River reworked the deposits of the 1954 and 1955 debris flows

B. (February 20, 1991; D. Edwards). Although the stage was about 0.5 m higher than in the 1958 view, 6-10 boulders with diameters of 1 m or larger remain. Most of the foreground debris fan was buried by debris flows in 1963 and 1966. The debris fan decreased in size slightly between 1958 and 1991 although the size of boulders in the reworked zone appears unchanged.

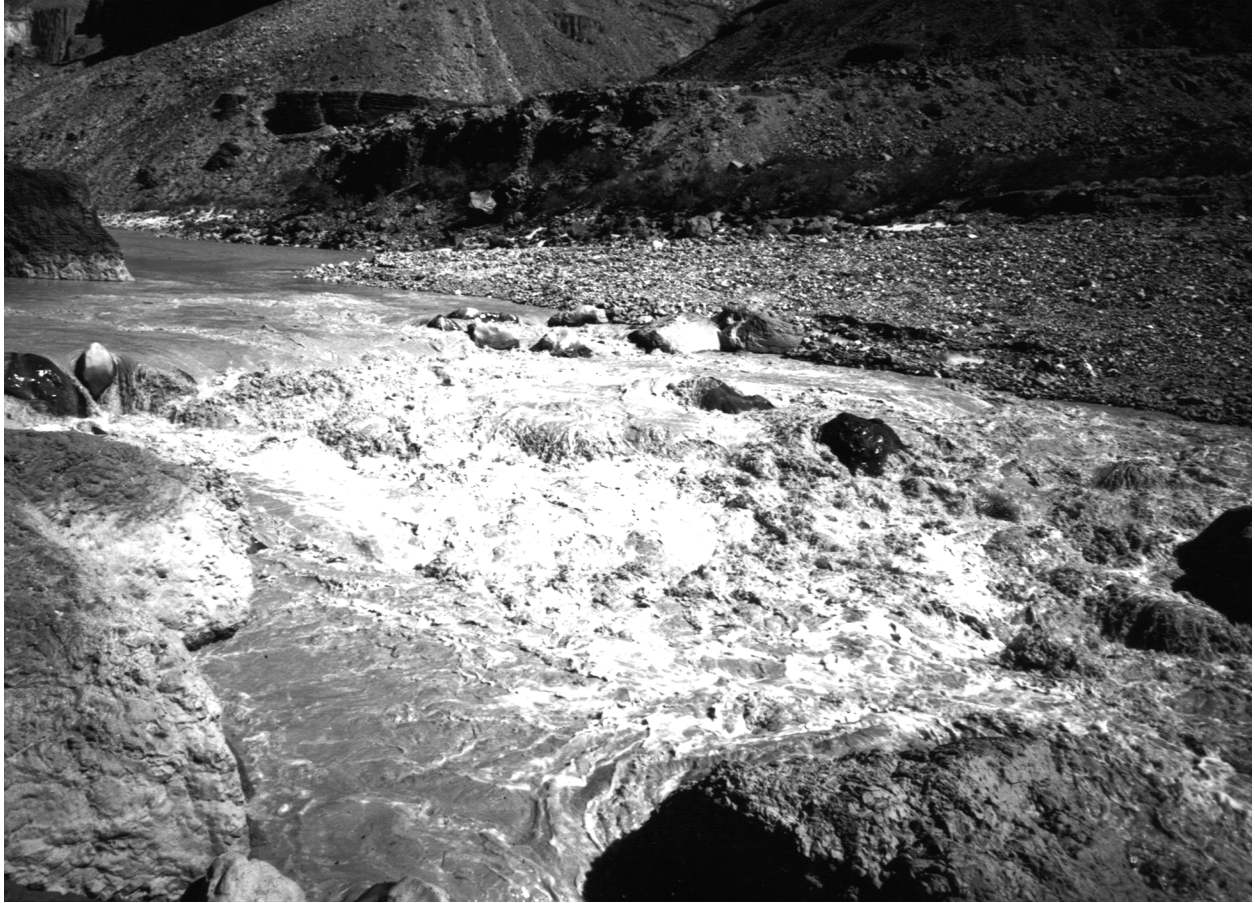
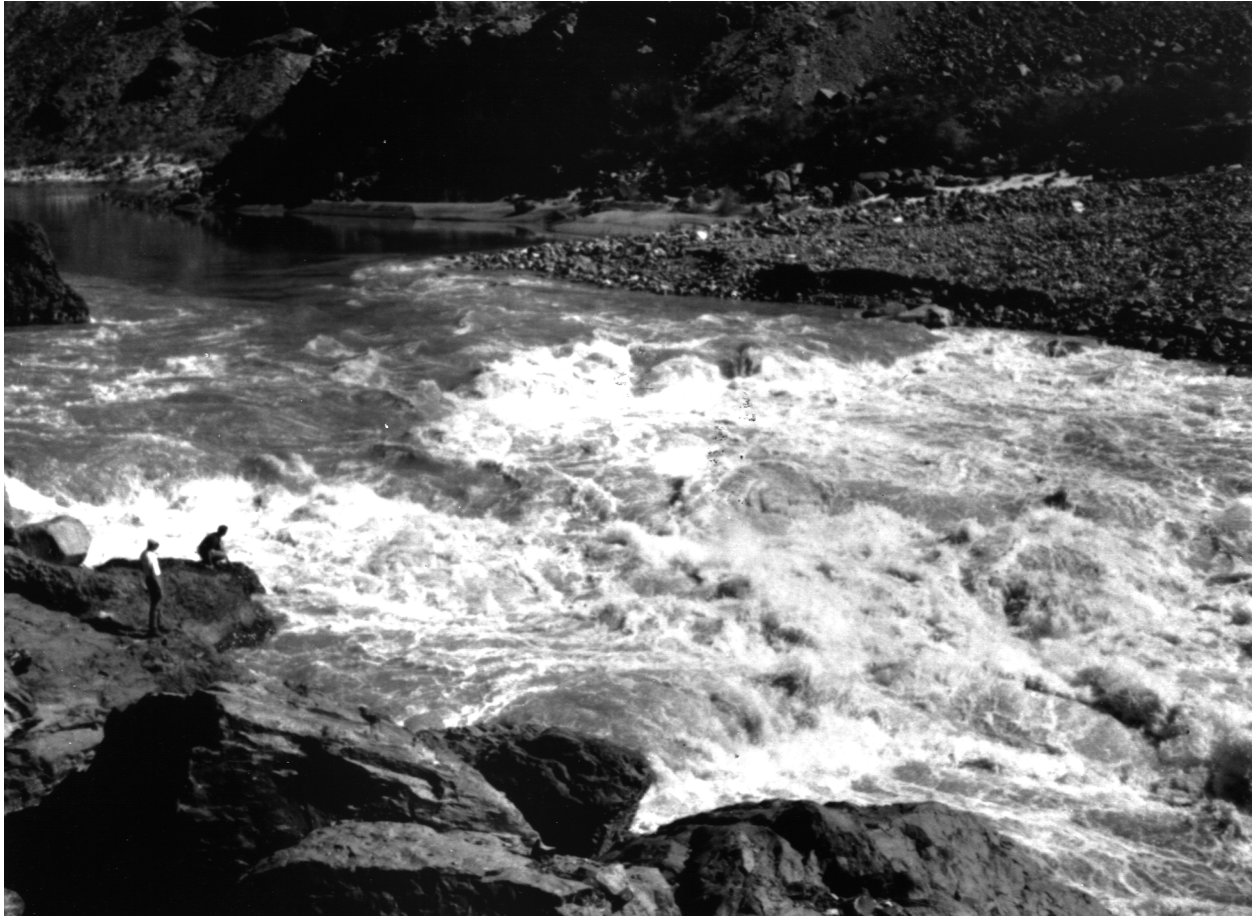
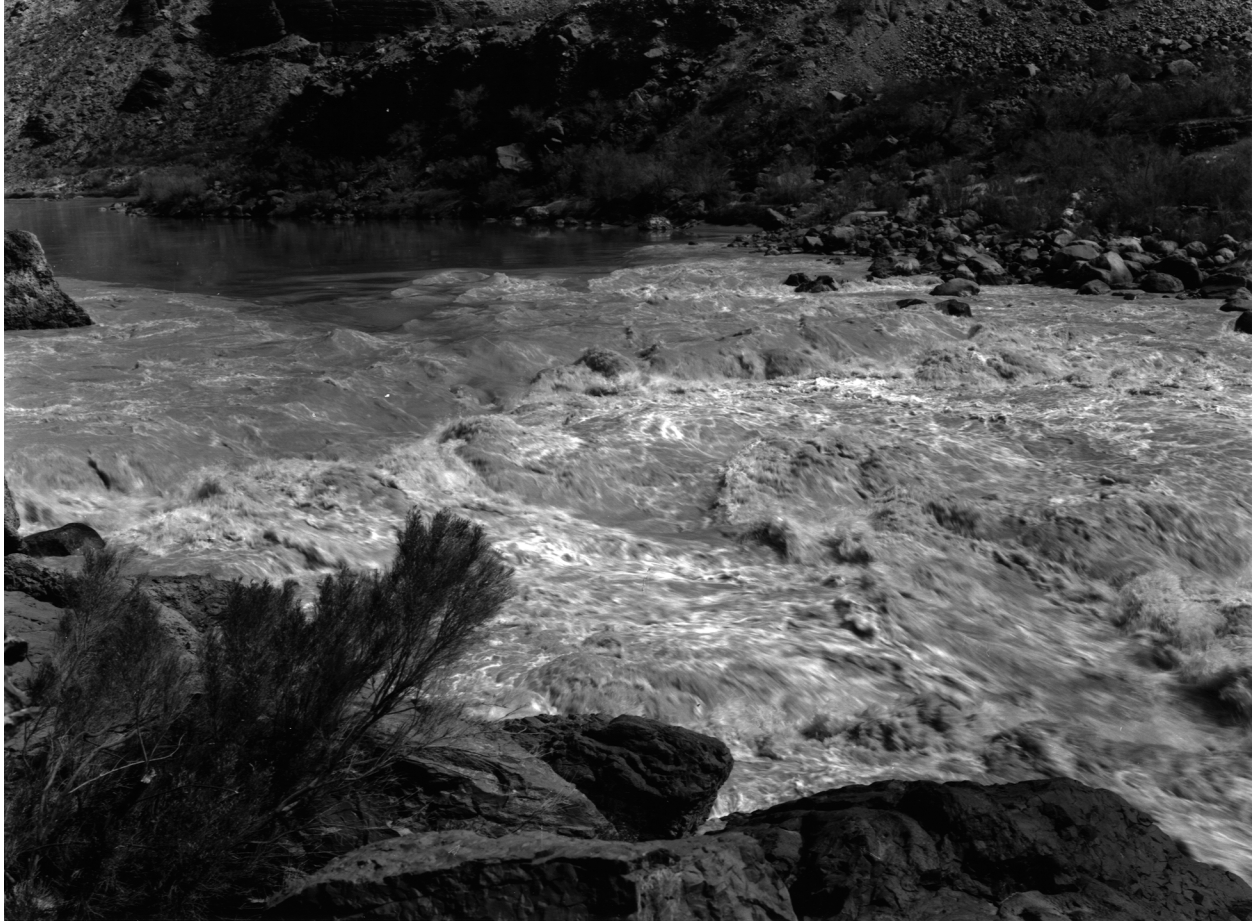
Figure 23. Upstream view of Lava Falls Rapid from the right side (Stakes 2005 and 3050). A. (September 25, 1963; photographer unknown, courtesy of the Huntington Library). This photograph was taken a short time after the September 1963 debris flow and shows its maximum constriction at a discharge of about $56 \text{ m}^3/\text{s}$. Boulders on the distal margin of the debris fan and in the center of the view created the Ledge Hole at higher discharges. The Meteor Rock, which creates the V Wave, appears on the right side of the view. The view shows the relatively fine-grained particle size that is characteristic of the 1963 deposits.

B. (February 21, 1965; J. Visbak, courtesy of the Huntington Library). This view, which is not a match of A, shows Lava Falls at a discharge of about $198 \text{ m}^3/\text{s}$. Dam releases up to $550 \text{ m}^3/\text{s}$ eroded the distal edge of the debris-flow deposit from 1963 through early 1965. Unlike the 1939 and 1955 debris flows, photographic evidence suggests that few boulders greater than 1 m in diameter were transported in the 1963 debris flow. As a result, most boulders in the 1963 debris flow fan were entrained during high dam releases in May-June, 1965.

C. (March 10, 1993; L. Hymans). The discharge was about $350 \text{ m}^3/\text{s}$ in this match of the 1963 view. Reworking of the 1963 and 1966 debris-flow deposits was complete by that time, leaving little evidence of the former constriction. The boulders forming the Ledge Hole are submerged in this view but their hydraulic effect is clearly visible in the center of the view. The Meteor Rock was also covered, but the noteworthy hole that forms downstream of the Meteor Rock is visible.

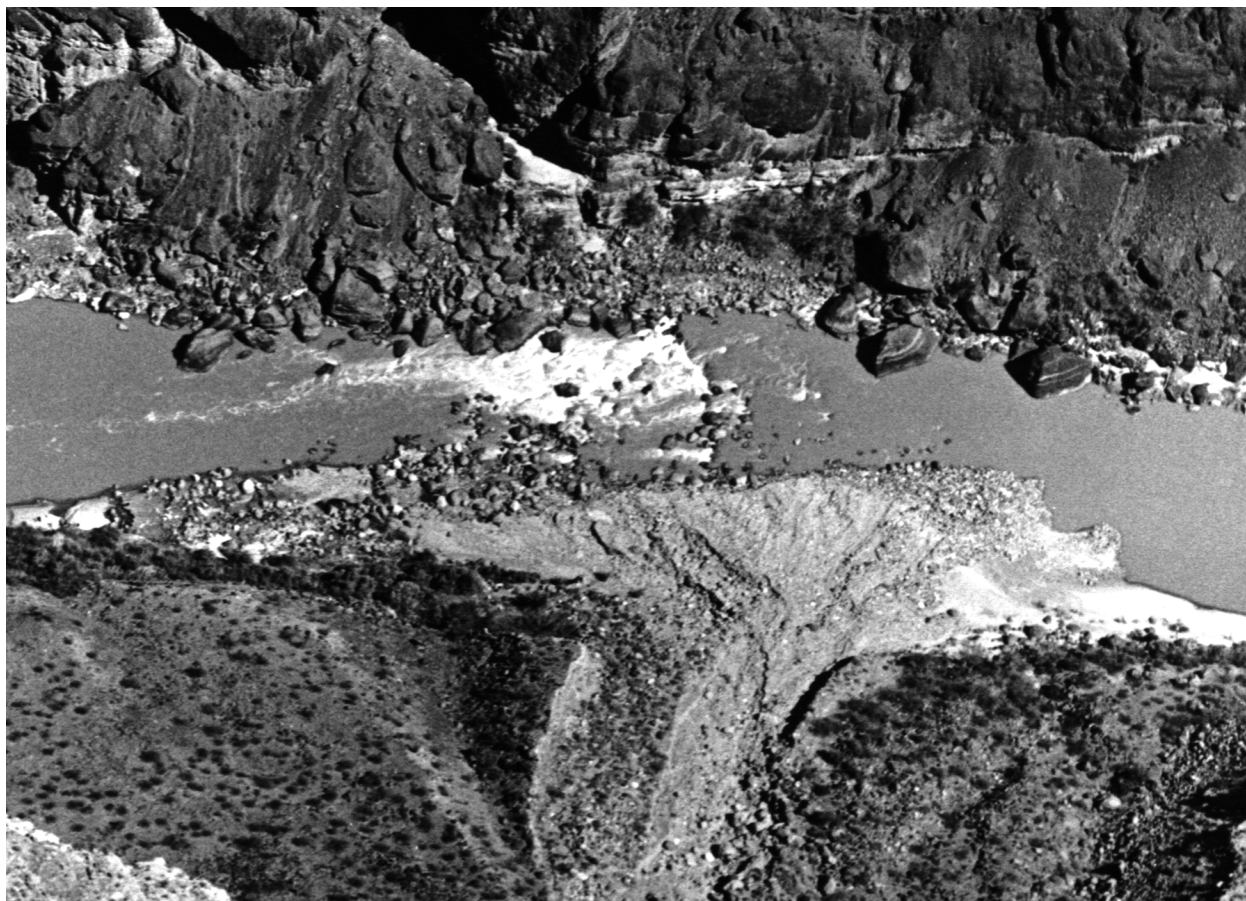
Figure 24. Oblique aerial view of Lava Falls Rapid and Prospect Canyon (May 20, 1964; P. T. Reilly). At a discharge of $37 \text{ m}^3/\text{s}$, the 1963 debris-flow deposit constricts the river by about 60 percent; the debris fan initially extended nearly to the middle of the Ledge Hole. This view shows the reworking by a peak discharge of $540 \text{ m}^3/\text{s}$. The Meteor Rock is visible in the center of the rapid, and the typically submerged Deflector Rock divided the tail waves.

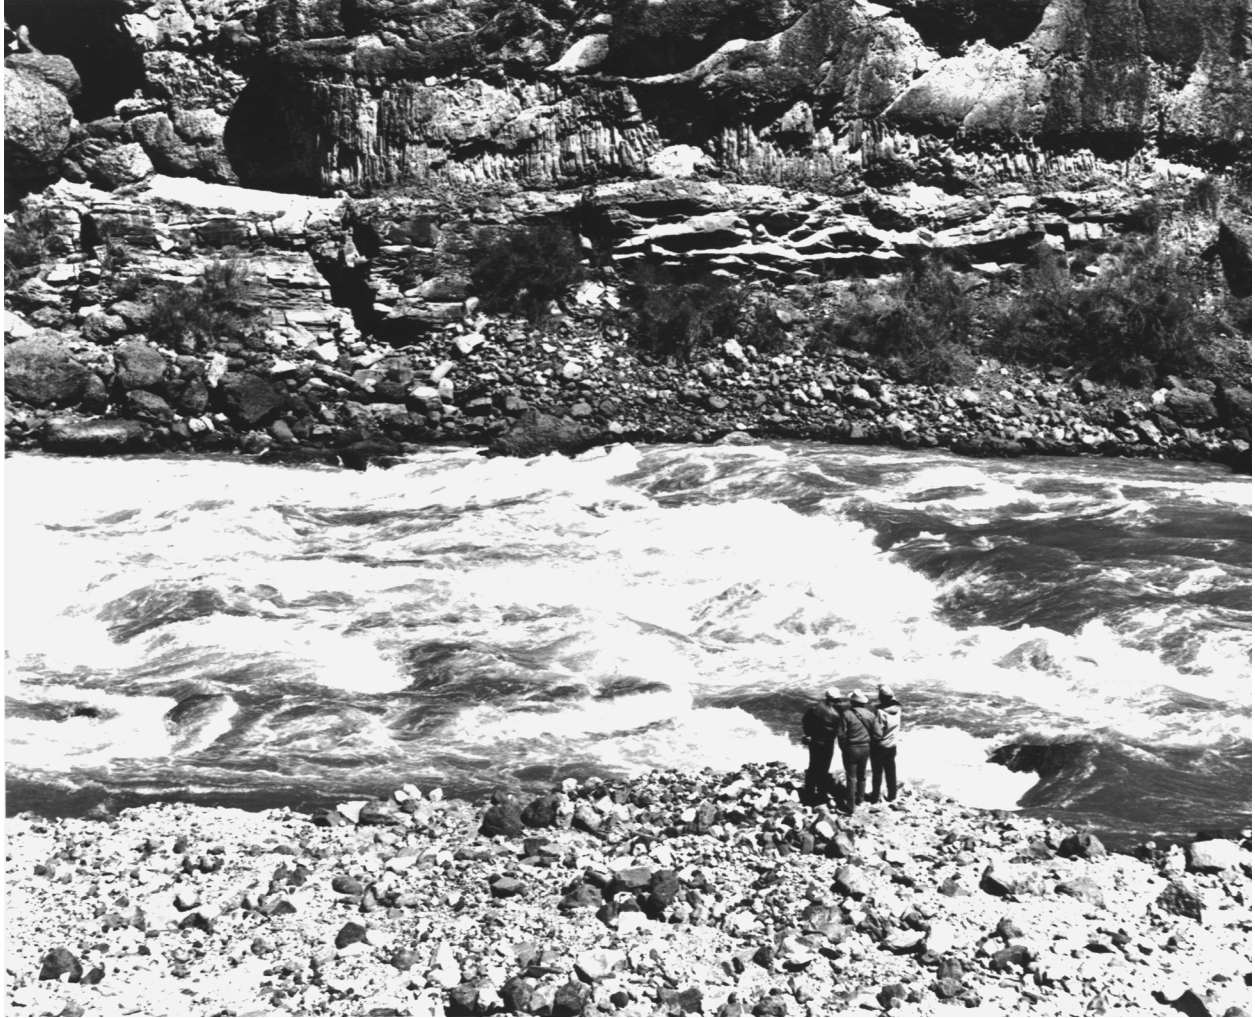
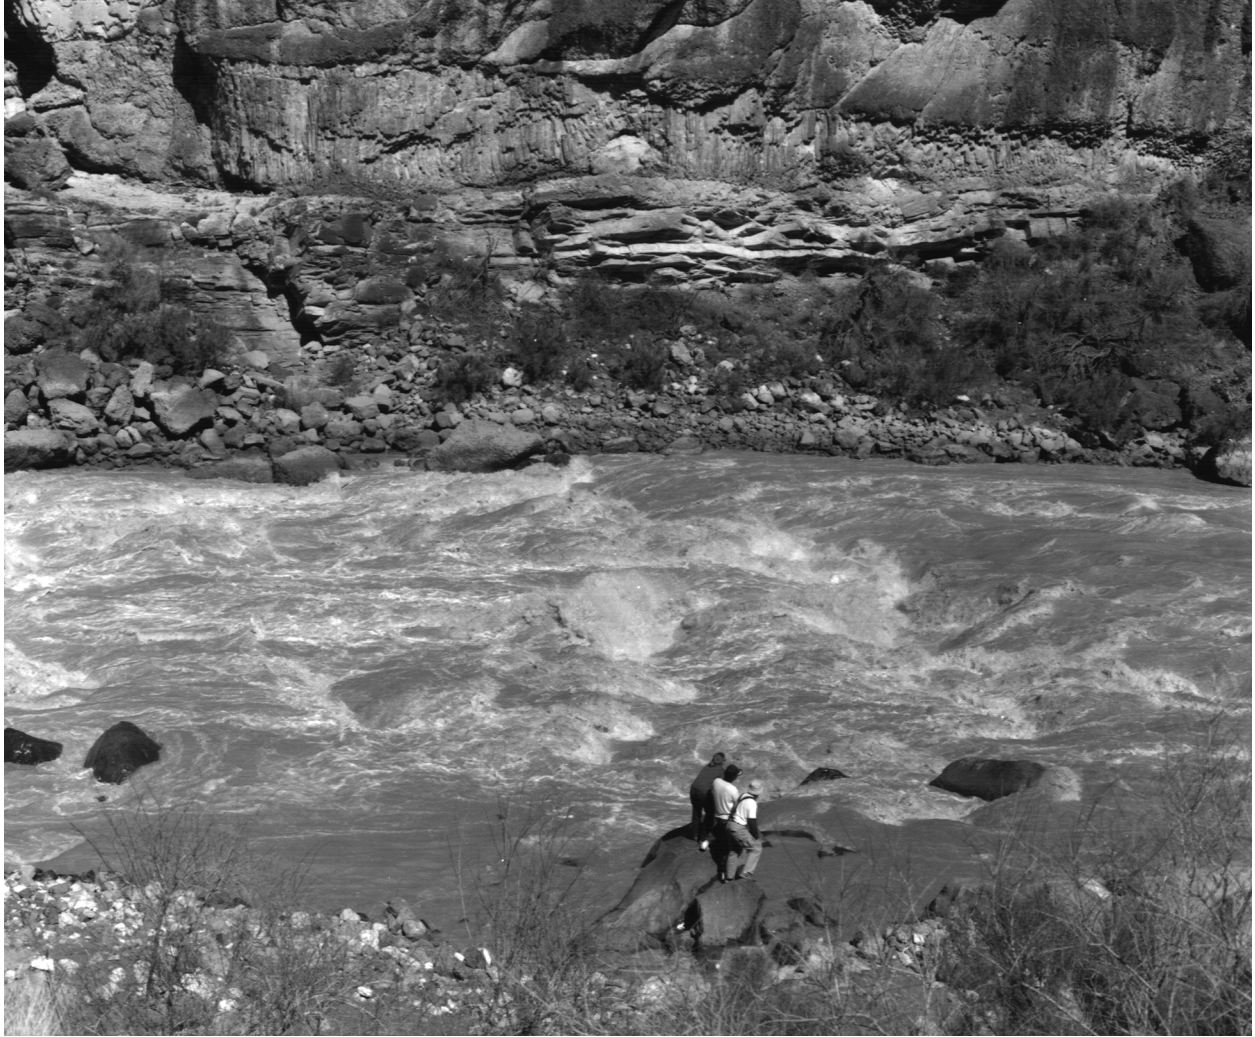
Figure 25. View from the left side across the top of Lava Falls Rapid (Stake 2739). A. (April 30, 1967; D. Harris). The crew of this 1967 trip stands on the 1966 debris-flow deposit while scouting routes through the rapid, which had a discharge of about $280 \text{ m}^3/\text{s}$. The largest visible boulder in the 1966 deposit is less than 1 m in diameter.

B. (March 8, 1993; R.H. Webb). The discharge was slightly lower than that in 1967. Most of the 1966 debris-flow deposit was removed in April 1973; the 1983 flood ($2,720 \text{ m}^3/\text{s}$) caused few changes in Lava Falls. The largest boulders, which controlled the major waves and holes in the rapid, were unchanged.

Photographs taken in July 1966 and April 1967 document the occurrence of a small debris flow in Prospect Canyon (appendix 1; table 4; figs. 25a, 26a). The deposition was first observed in March 1967 by the first river runner that year (John Cross II, written commun., 1967). An unusually intense winter storm in December 1966, which caused debris flows in Crystal Creek (mile 98.3), Lava
